OPERATIONS DEPARTMENT	R&F-OPDE-OP-FO-04
	INTEGRATED MANAGEMENT SYSTEM	REVISION N°: 1
	SERVICES DETECTION REPORT	ISSUE: APR/2021
		PAGE 1 OF 3

Economic Proposal #: R&F-	2726095	S. Order #: R&F-SO-	2726073	Service Report #: R&F-SDR-	2726034

CUSTOMER	SERVICE ADDRESS	# TELEPHONE	EMAIL
[redacted]	1311 U.S. Hwy 301 N #9, Wilson, NC 27893	(919) 792-7160	[redacted]
SOLICITED SERVICE	**SERVICES_LOCATE: All Underground Services| PURPOSE: Excavation for rainwater pipe installation| AREA: 600 Ft**

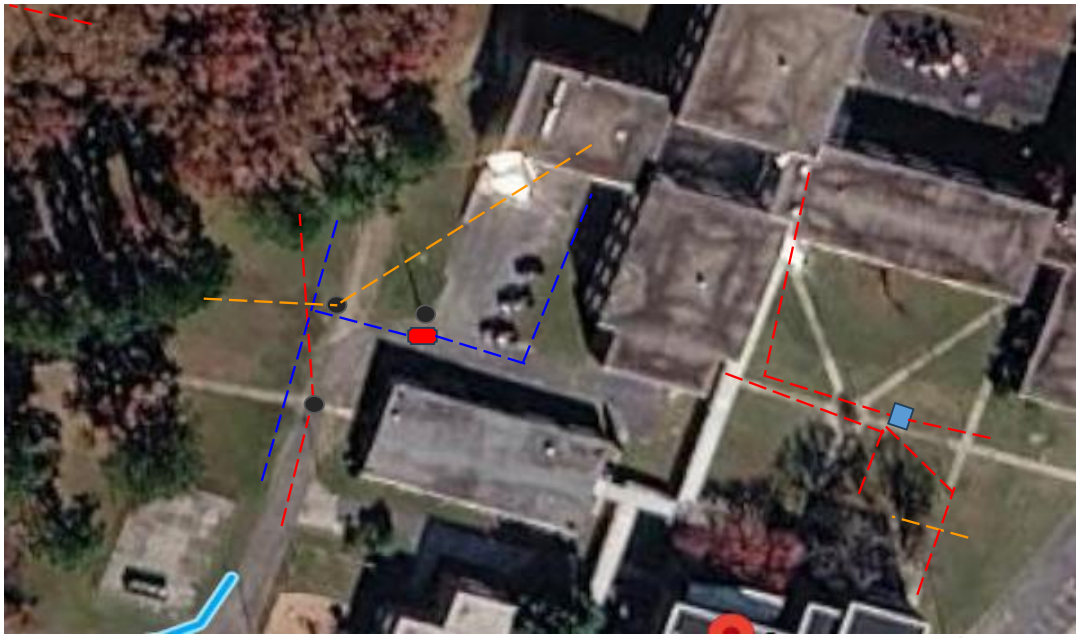
SKETCH

The following buried services were located and marked
Potable line located, marked with Blue paint.
Power line located, marked with Red paint.
Communications line located, marked with Orange paint.

If you need to excavate near the Marking, do the excavation manually. The Builder must compulsorily carry out exploratory pits, if it is going to cross an existing Service
