OPERATIONS DEPARTMENT	R&F-OPDE-OP-FO-04
	INTEGRATED MANAGEMENT SYSTEM	REVISION N°: 1
	SERVICES DETECTION REPORT	ISSUE: APR/2021
		PAGE 1 OF 3

Economic Proposal #: R&F- 2724211	S. Order #: R&F-SO- 2724087	Service Report #: R&F-SDR- 2724035
--	------------------------------------	---

CUSTOMER	SERVICE ADDRESS	# TELEPHONE	EMAIL
COMBS ELECTRIC GROUP	651 N Winstead Ave, Rocky Mount, NC 27804	(919) 337-5493	bcombs@combselectricgroup.com
SOLICITED SERVICE	SERVICE TO LOCATE:Water and Sewer PURPOSE:Excavation for cable installation AREA: 110' x 10'

UNDERGROUND SERVICES DETECTION REPORT

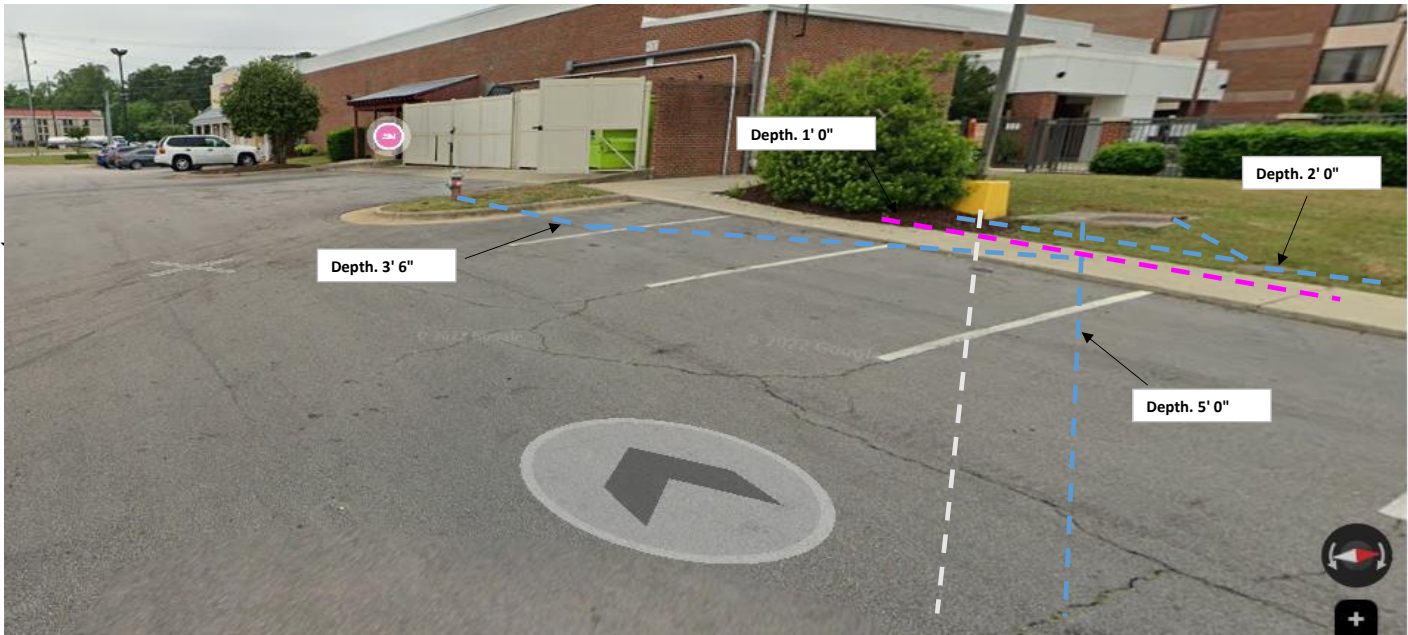
Sketch

The following buried services were located and marked
- Main Water Line - Depth 5' 0" Marked with Blue Paint
- Hydrant Feed Water Line - Depth. 3' 06" Marked with Blue Paint
- Meter Water Line - Depth 2' 0" - Marked with Blue Paint
- Irrigation Line -- Depth 1' 0" - Marked with Purple Paint

Note: The Markings of the Services in the Sketches are referential and approximate.

In the area adjacent to the power pole, you must excavate by hand after cutting the asphalt pavement and concrete, due to the multiple services in the area.
